Ballyalton to Myra Road (Part of Section 1 of Lecale Way)

Report of issues September 2020

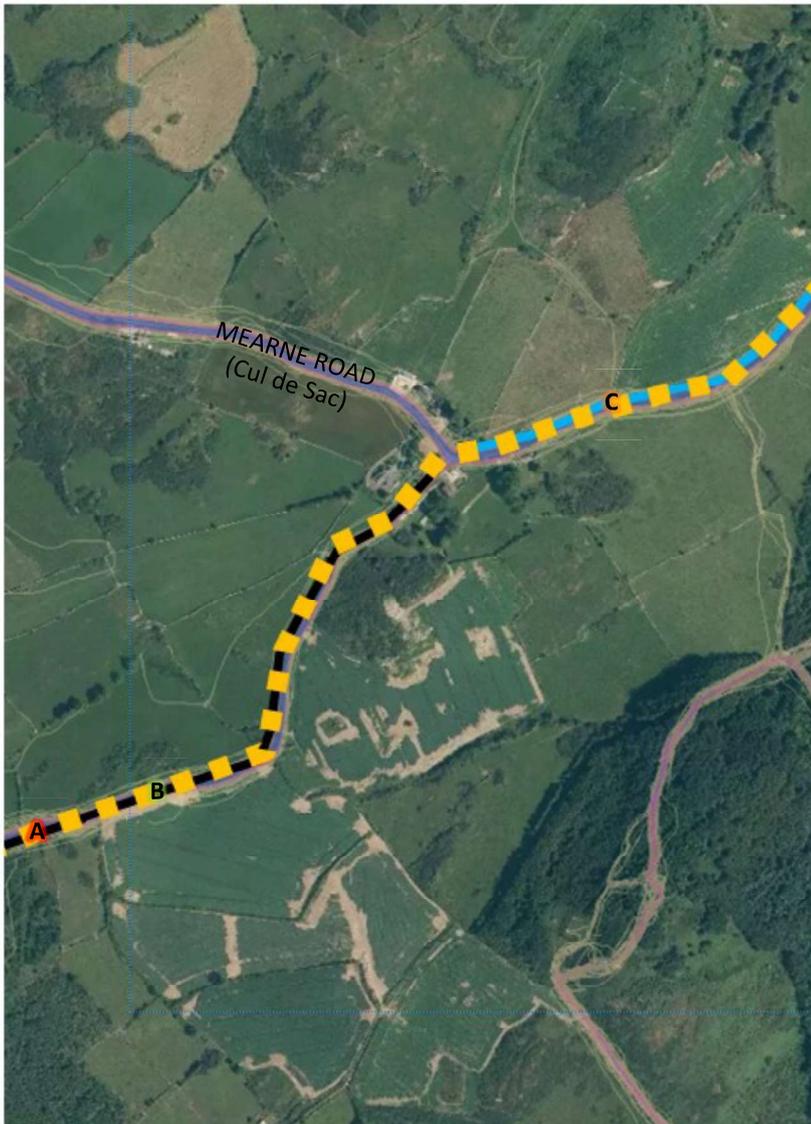
Area 1

A Overgrown boardwalk. A small spring in the field to the south crosses and floods the PRoW. To assist in crossing a boardwalk is located here. This is set to the side of the path to allow horseback riders to use the route. At present the boardwalk is overgrown from overhead vegetation and underfoot and beginning to decay. There are a number of excess boardwalks nearby which could be used as replacements.

B Overgrown section. In general much of the PRoW is in need of cutting back. In some places this also requires overhead pruning.

C Flooded section. A soakaway should be dug here to allow the rain to drain off.

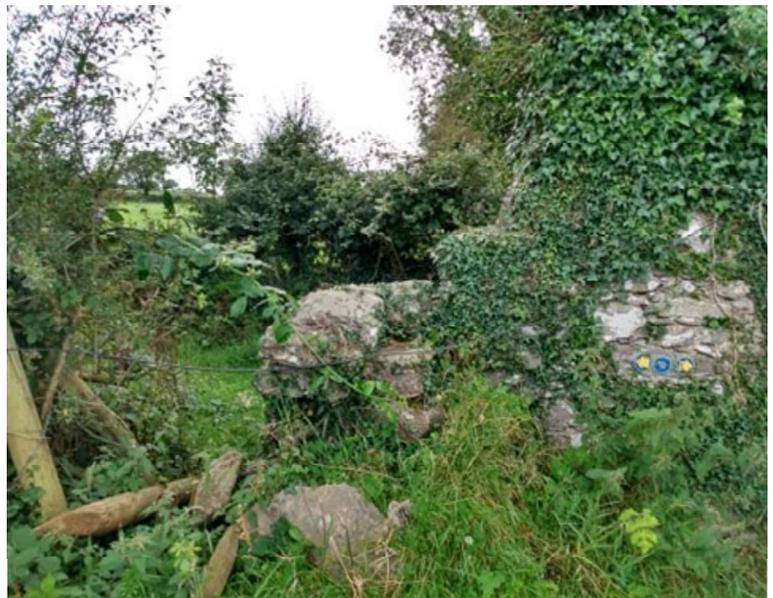
3 – Stile in disrepair and hazardous telephone line

At the point where the path leaves the lane to cross the field the stile is partially broken and dangerous to use. On the other side of the stile there is a telephone line down which acts as a trip hazard.

Photo 1 — Issue 3. The telephone line is lying adjacent to the stile in the foreground. The use of the stile is hampered by the broken down fence also in the foreground.

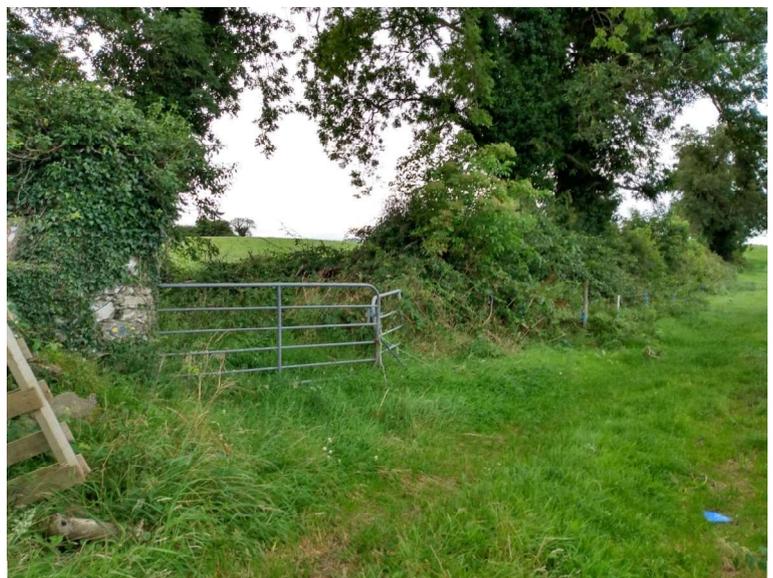
4 – Presence of agricultural electric fencing

Around the field which the pathway crosses there is an agricultural electric fence. This is likely to deter use of the path.

Photo 2 — Issue 4. On various occasions the electric fence has been found to be blocking access to the field. This requires walkers to take it down, climb over or duck under it.

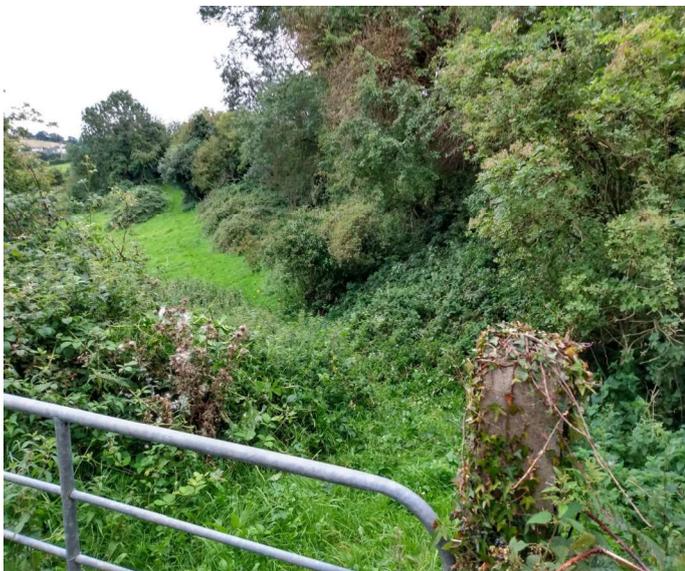
1 – Growth of vegetation on the path.

This particular section has notably more vegetation growth that the preceding section to Roneystown. This is in part due to a lack of use which has been encouraged by diversions in recent years. The vegetation causing issues also includes fallen boughs on trees. These areas are denoted on the map by a number 1.

Photo 3 — Issue 5 and an example of Issue 1.

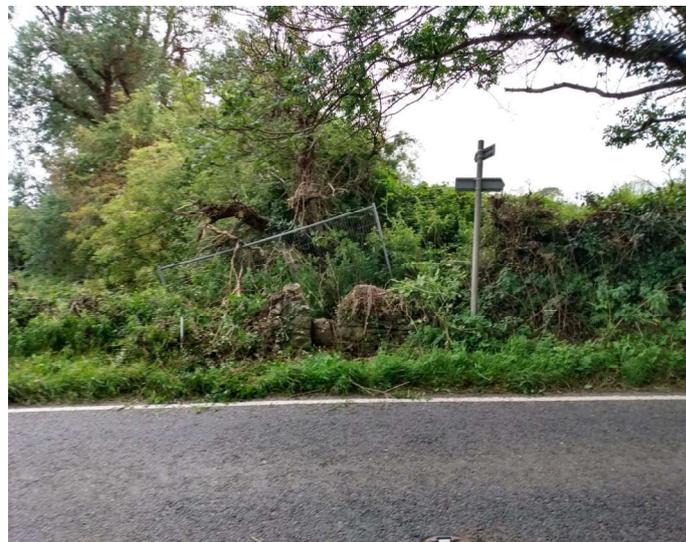
Photo 4 — Issue 5. Lecale Way signage on right hand side adjacent to the stile which walkers should be using.

5 – Overgrown stile

As the field path joins onto the Strangford Road the path to the stile is overgrown. There are two sections of heras fencing placed deliberately in the corner to stop use of this section. This issue has been in situ for a number of years when the section of off-road path from Strangford Road to Myra Road was diverted. The issue is circumvented by the presence of an agricultural gate adjacent. However, use of this gate does leave the user liable for damages if they were to forget to close it correctly.

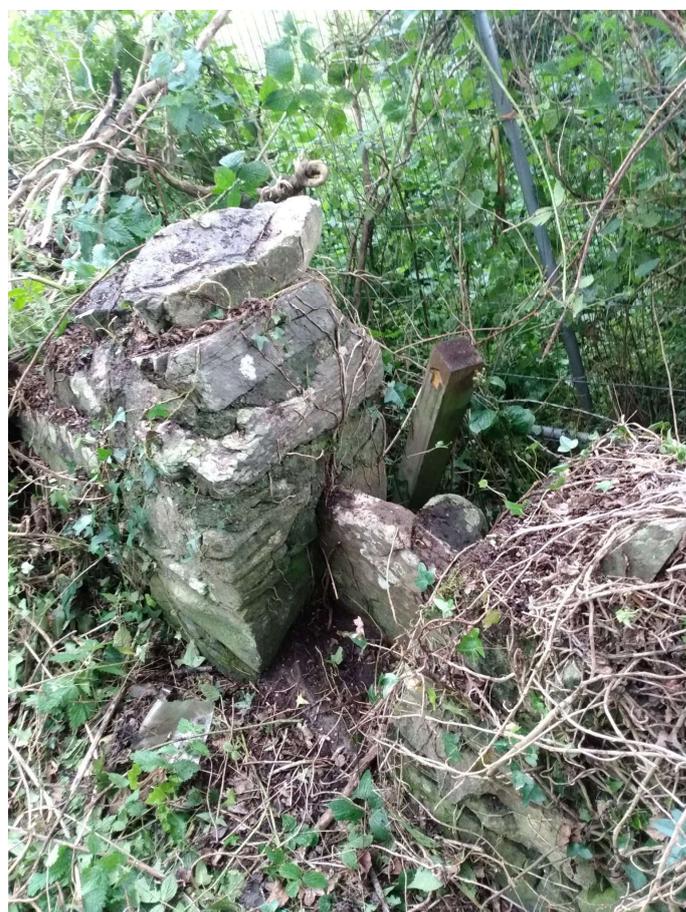
Photo 5 — Issue 5 as seen from above. Lecale Way marker post can be seen clearly. Heras fencing has been placed against the wall stopping use.

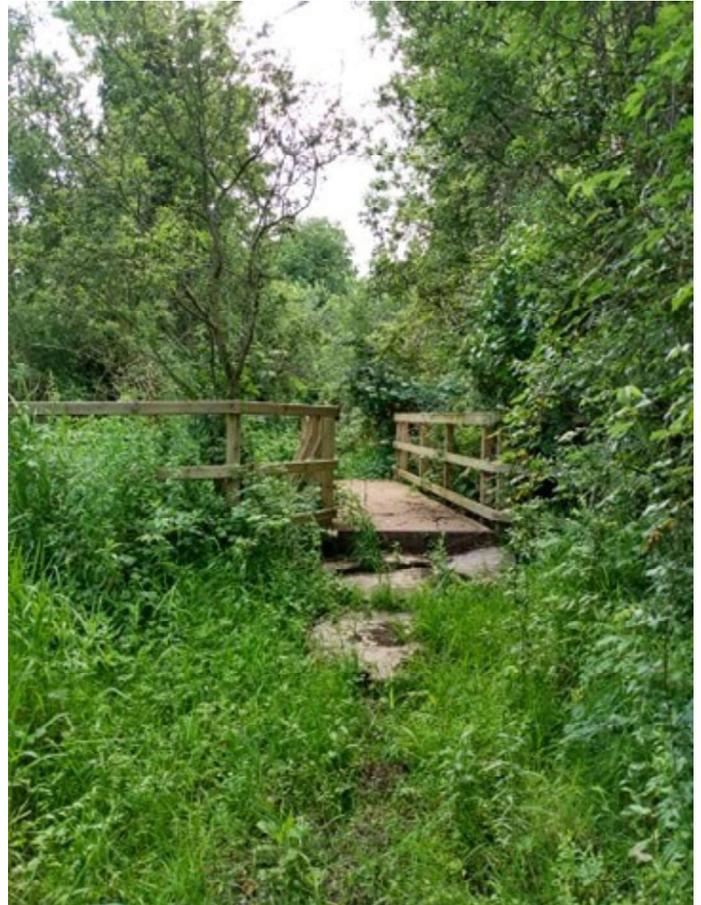
7 – Lack of drainage

Around the new footbridge across the River Slaney the ground is sodden at all times. The western section can be crossed with some trepidation. The eastern section is more problematic. The remains of the old stone bridge have been left in situ and the surface of the path has not been returned to its original state. As you walk towards the Myra Road there is an excavated trench which floods and the right hand side of the path is formed of a raised bank which is uneven.

Photo 6 — Issue 7. The area immediately in the foreground is flooded and is an excavation trench. The walkable path is on the left hand side of the photo. Remnants of old bridge can be seen in front of the footbridge.

The remedial works for this particular issue should in the first instance be to construct two sheughs on both sides of the bridge to allow the water to freely drain away. In addition the bridge surface should be extended to create a raised boardwalk on both sides of the bridge.

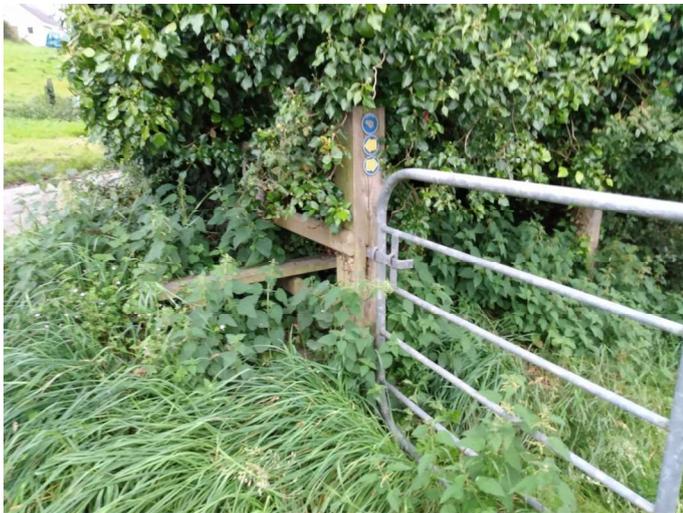
Photo 7 — Issue 8 overgrown stile and example of Issue 1.

Issue 8 – Over grown stile

The stile at the Myra Road is overgrown which means that walkers must use the gate.

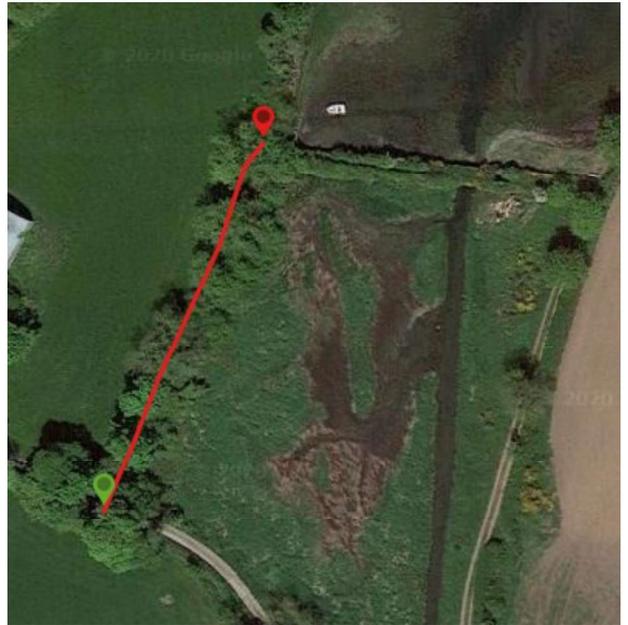
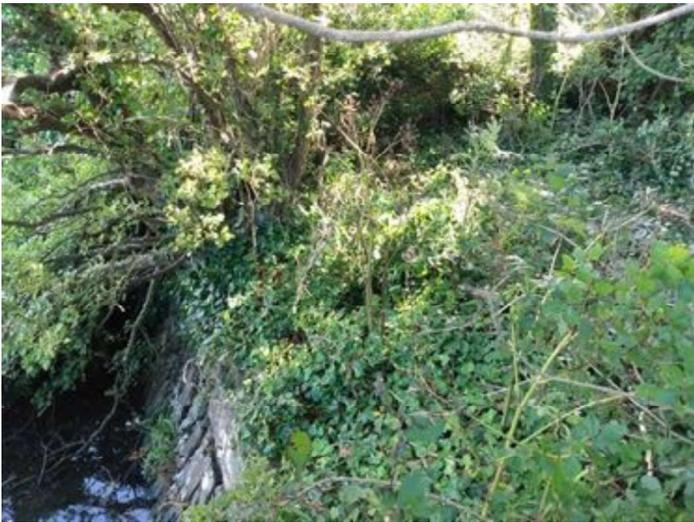
The entrance to the PRow should be from two points on the Myra Road either side of the Slaney River bridge. The Eastern entrance is passable around the edge of the gate on foot and follows the well-marked lane on the right of the satellite image. However, the Western entrance on to the old quay wall has become completely overgrown and is at present impassable. For reference, this is shown on red in the satellite image. The total length of the blockage is about 100m.

The image below shows the quay wall and the extent of the vegetation blocking.

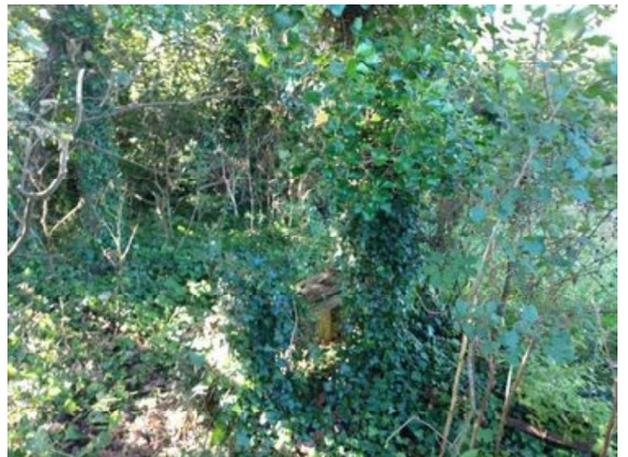
The barrier which the PRow crosses on is becoming overgrown also. The Barrier begins at the red point on the satellite image and is about 80m in length. There are also the remnants of a stile (shown here on the right) which should be removed.

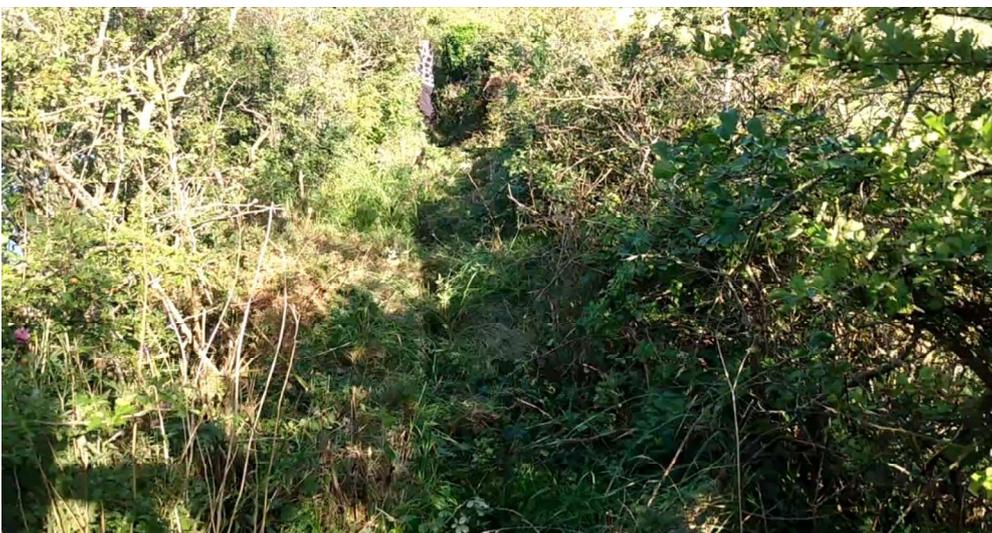
Below is an image of the extent of the vegetation growth on the barrier. This should be faced back to allow free passage.
